MAY 2022

# EVALUATION OF ACTIVE DRIVING ASSISTANCE SYSTEMS

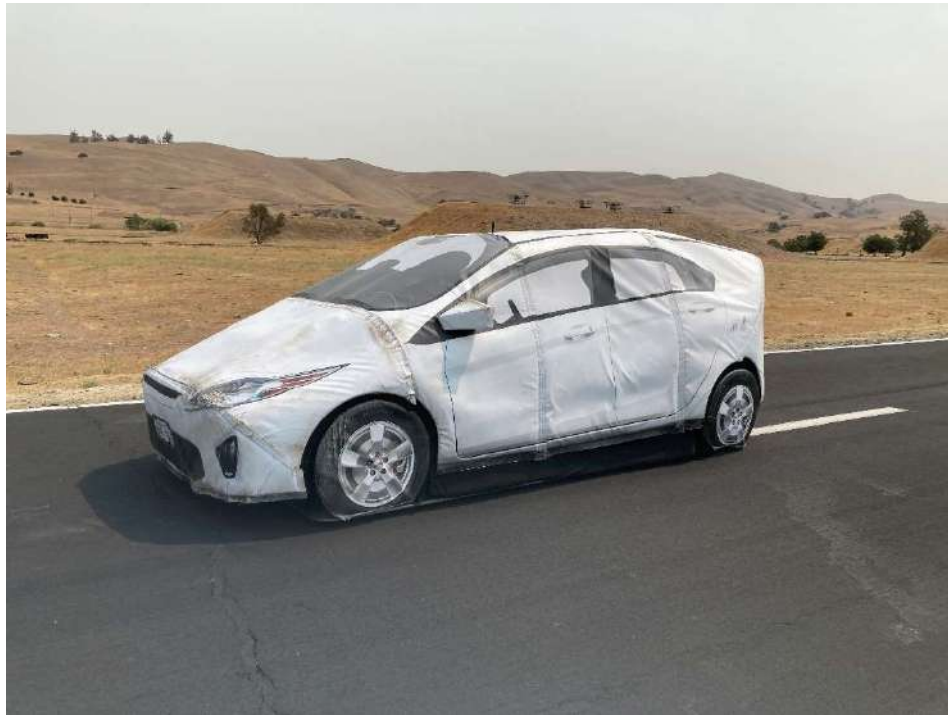
Figure 7: DRI Low Profile Robotic Vehicle Image Source: AAA

The robotic vehicle is a hardened, satellite guided, self-propelled, low-profile vehicle, which serves as a dynamic platform for the DRI Soft Car. The LPRV has a top speed of 50 mph and a maximum deceleration rate of 0.8 G. The positions of the vehicle under test and LPRV are measured continually using differential GPS with RTK correction. Kinematic data relating to the vehicle under test is broadcast to the LPRV via wireless LAN. This information in conjunction with pre-loaded time-space trajectories (one each for the vehicle under test and LPRV) allow the LPRV to arrive at predefined locations relative to the vehicle under test in a repeatable manner.

Additionally, data from the LPRV was processed by the OxTS RT-Range Hunter to calculate LRPV kinematics relative to the vehicle under test (vehicle under test acts as a non-Newtonian reference frame).

The Soft Car 360® is calibrated to be representative of a small passenger vehicle relevant to automotive sensors including radar and cameras. The hatchback model was utilized for testing; its length, width and height are 158 in, 67 in, and 56 in, respectively.

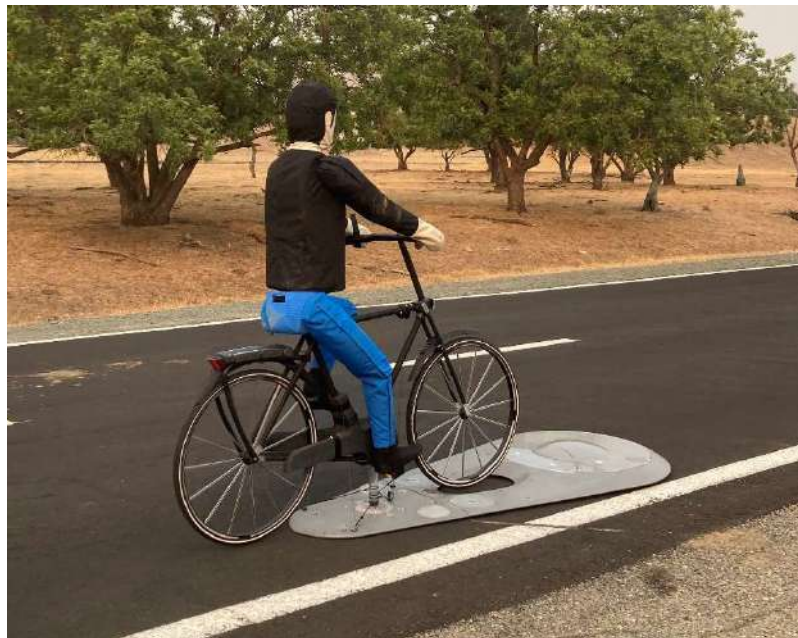
Figure 8: 4activeFBsmall platform with 4activeBS-adult cyclist target Image Source: AAA

The FBsmall robotic platform is utilized for dynamic test scenarios involving vulnerable road users (VRUs) i.e. pedestrians, cyclists, and motorcycles. The platform is designed according to Euro NCAP and ISO specifications with integrated dual antenna GNSS/IMU and full synchronize mode with the vehicle under test to allow for consistent run-to-run target positioning. The positions of the vehicle under test and FBsmall are measured continually using differential GPS with RTK correction. Kinematic data relating to the vehicle under test is broadcast to the FBsmall via wireless LAN. Data from the FBsmall was processed by the OxTS RT-Range Hunter to calculate FBsmall kinematics relative to the vehicle under test (vehicle under test acts as a non-Newtonian reference frame).

The 4activeBS-adult is the official Euro NCAP cyclist target and represents an average European adult male on a standard bike. The target includes rotating wheels with realistic micro Doppler spread and other signal characteristics with respect to radar, lidar, camera and infrared sensors.

The height, wheel diameter and wheelbase of the bicycle is 47.2 in, 27.6 in, and 48.4 in, respectively. The height, shoulder width and torso angle of the cyclist is 70.9 in, 19.7 in, and 10°, respectively.

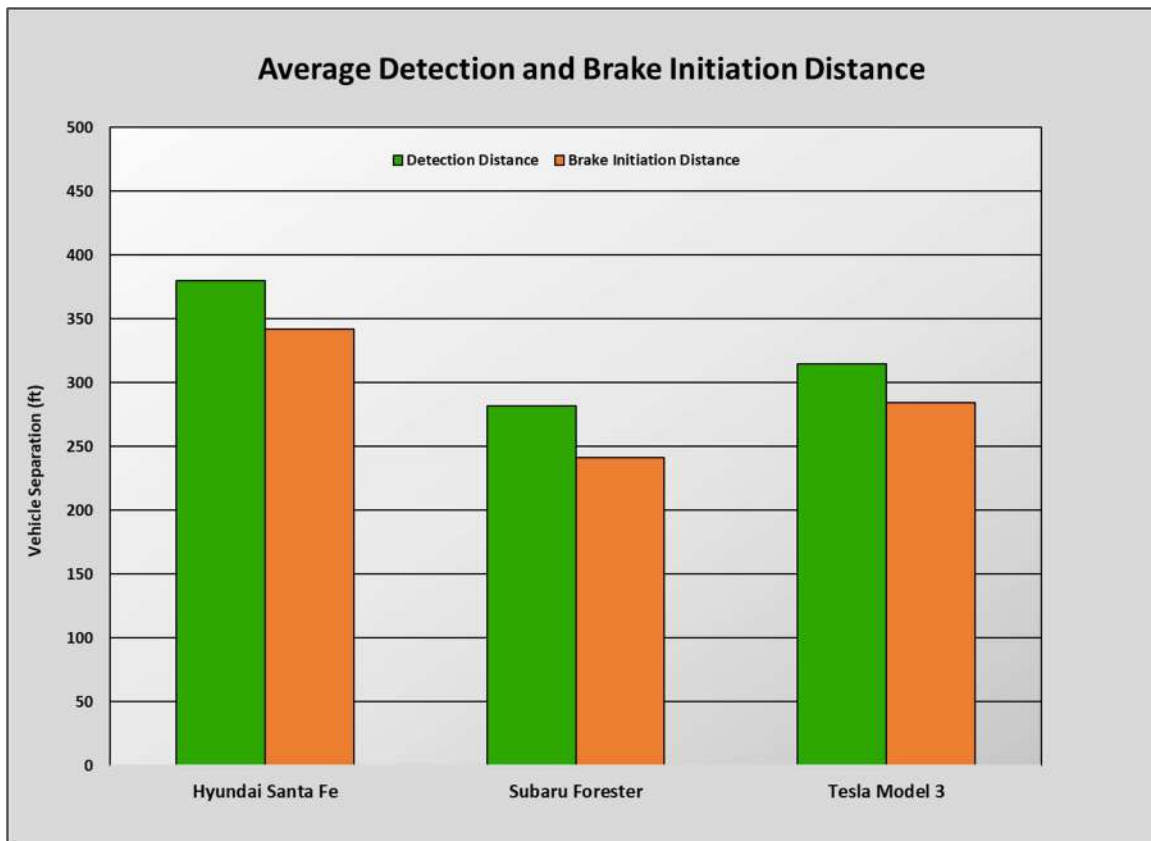
Figure 16: Average detection and braking initiation distances Image Source: AAA

Figure 16 illustrates average detection and braking initiation distances for each test vehicle. None of the vehicles provided an AEB warning for any test runs, indicating that ADA systems appropriately responded to the target vehicle. Of the three test vehicles, the Subaru Forester detected the slow-moving lead vehicle and initiated braking the latest, resulting in more aggressive braking relative to the other test vehicles. However, each ADA system appropriately decelerated the test vehicle at a gradual rate before following the target vehicle at a safe distance.

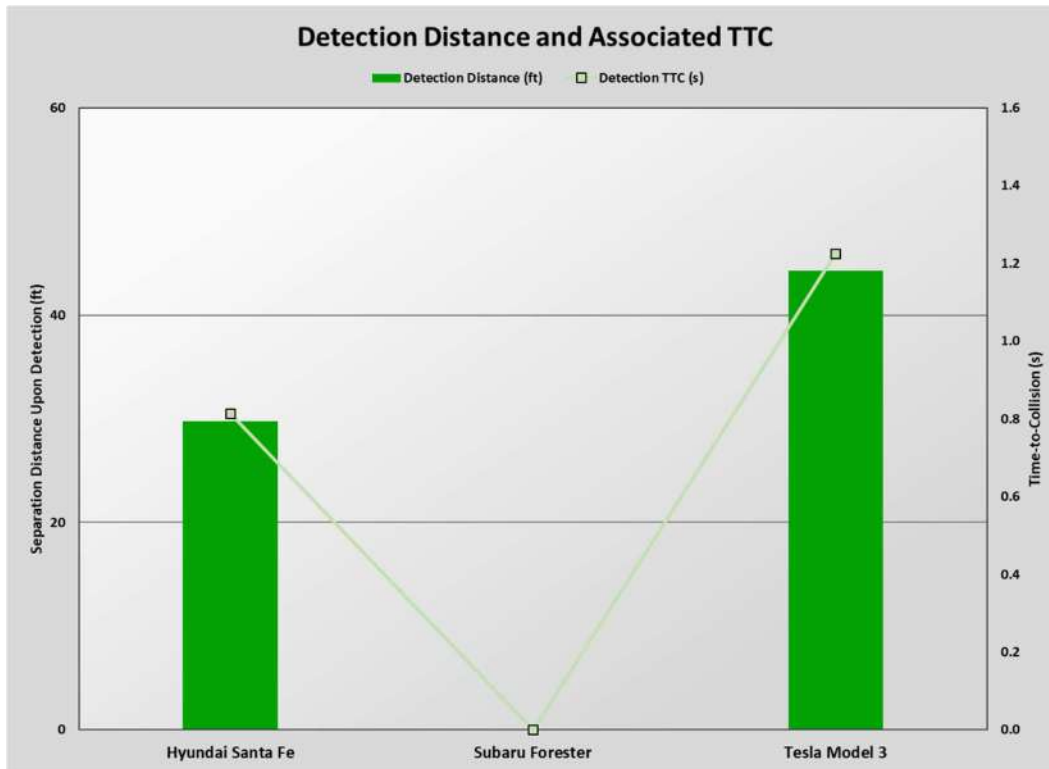
Figure 36: Average detection distance and associated TTC for all test vehicles Image Source: AAA

Figures 36 and 37 illustrate average distances and associated TTC for detection and braking initiation phases. Figure 38 illustrates the average minimum longitudinal separation distance between the test vehicle and cyclist target.

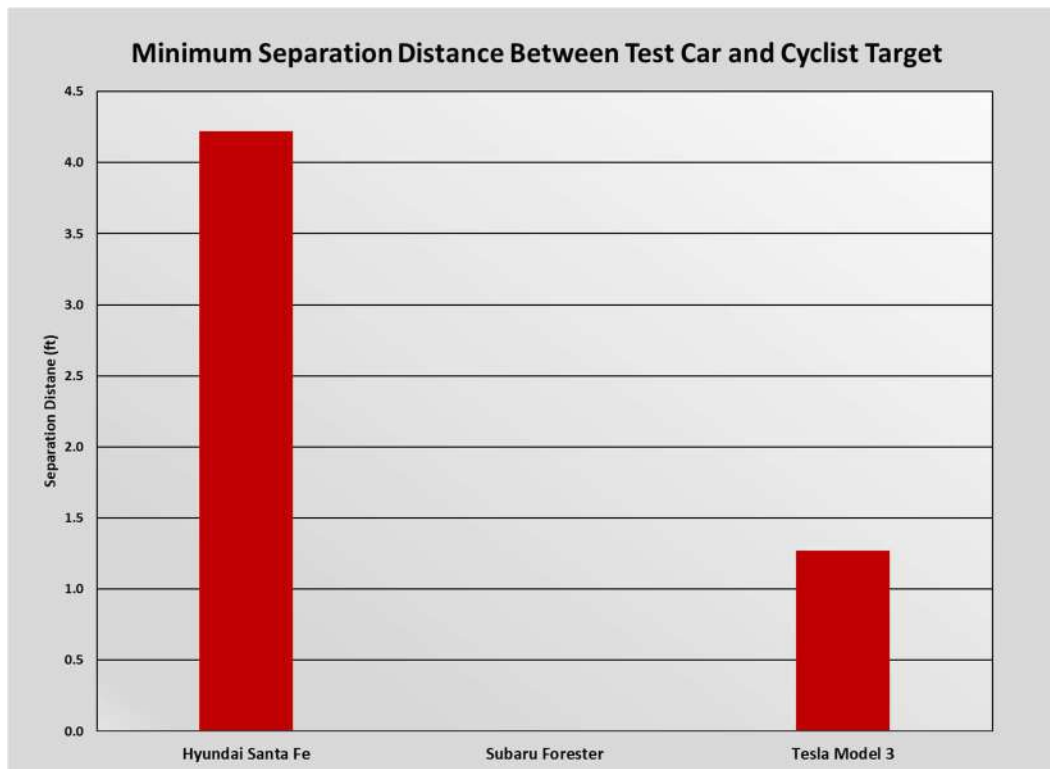
Figure 38: Average minimum separation distance and associated TTC for all test vehicles Image Source: AAA
