**AUGUST 2020**

# **EVALUATION OF ACTIVE DRIVING ASSISTANCE SYSTEMS**

In 2018, AAA evaluated four vehicles equipped with active driving assistance (ADA) systems. In common language, these systems assist the driver with vehicle acceleration, braking and steering. SAE<sup>1</sup> International defines various levels of driving automation within standard J3016 [1] and ADA systems currently available within the United States are considered to be Level 2 systems per this standard. To build upon work AAA conducted in 2018, the performance of five additional vehicles equipped with ADA systems was characterized.

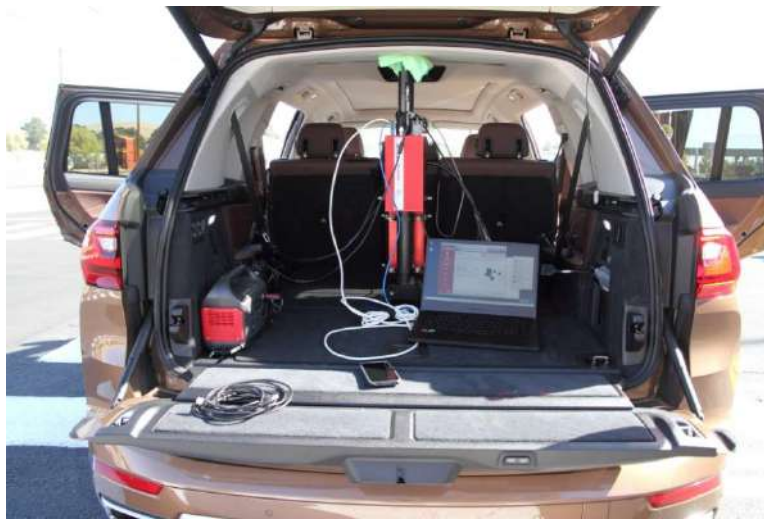
Figure 2: Test vehicle outfitted with closed-course instrumentation Image Source: AAA

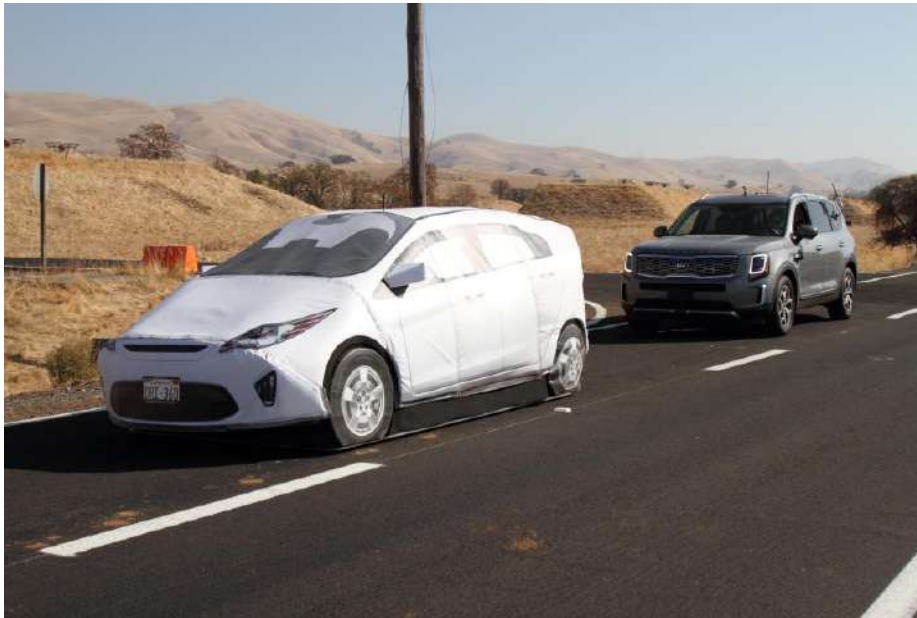
**Figure 8: DRI Low Profile Robotic Vehicle** Image Source: AAA

The Soft Car 360® is calibrated to be representative of a small passenger vehicle relevant to automotive sensors including radar and cameras. The hatchback model was utilized for testing; its length, width and height are 158 in, 67 in and 56 in, respectively.

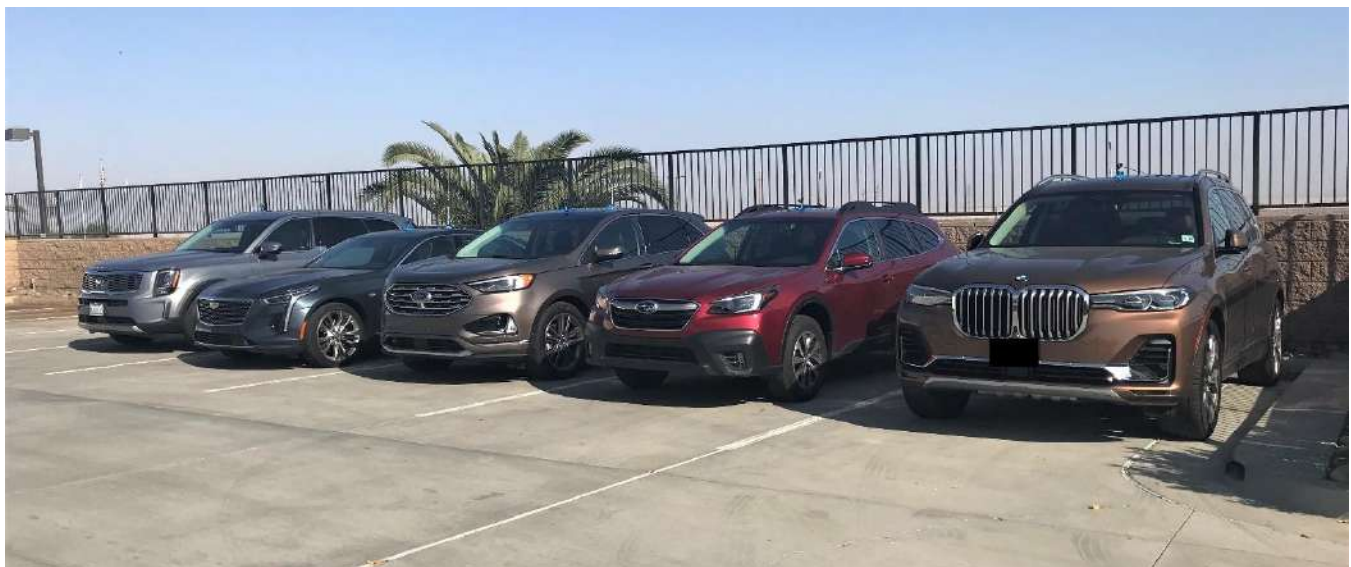
**Figure 9: Test vehicles outfitted with naturalistic instrumentation** Image Source: AAA

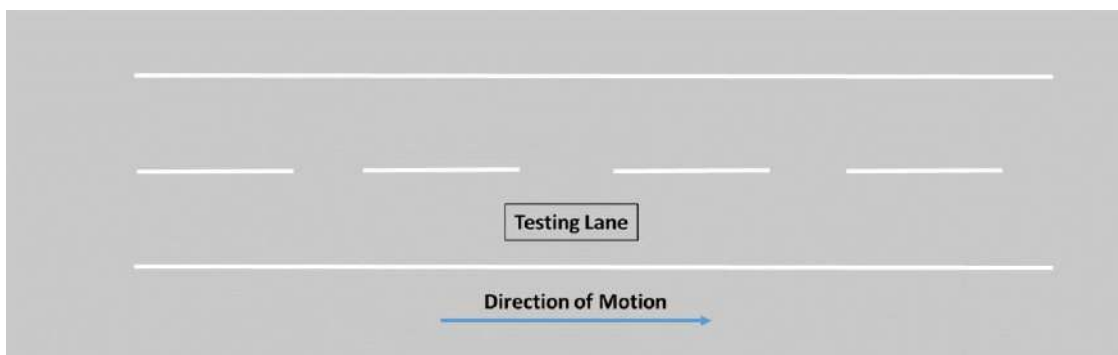
All testing was conducted on a dry asphalt surface free of visible moisture. The surface was straight and flat, free of potholes and other irregularities that could cause significant variations in the trajectory of the test vehicle. The testing area was approximately 0.4 miles long and consisted of a two-lane roadway divided down the middle by a dashed white line. The width of each dashed white line segment was 7 inches with a uniform spacing of 17 feet 2 inches between segments.

Figure 10: Illustration of testing surface Image Source: AAA

Each individual lane was marked by a solid white line on the lateral side and the previously described dashed white line on the medial side with a nominal lane width of 10 feet. This lane width is representative of typical roadways (excluding interstates and limited-access expressways with a nominal width of 12 feet) in both urban and rural areas within the United States.

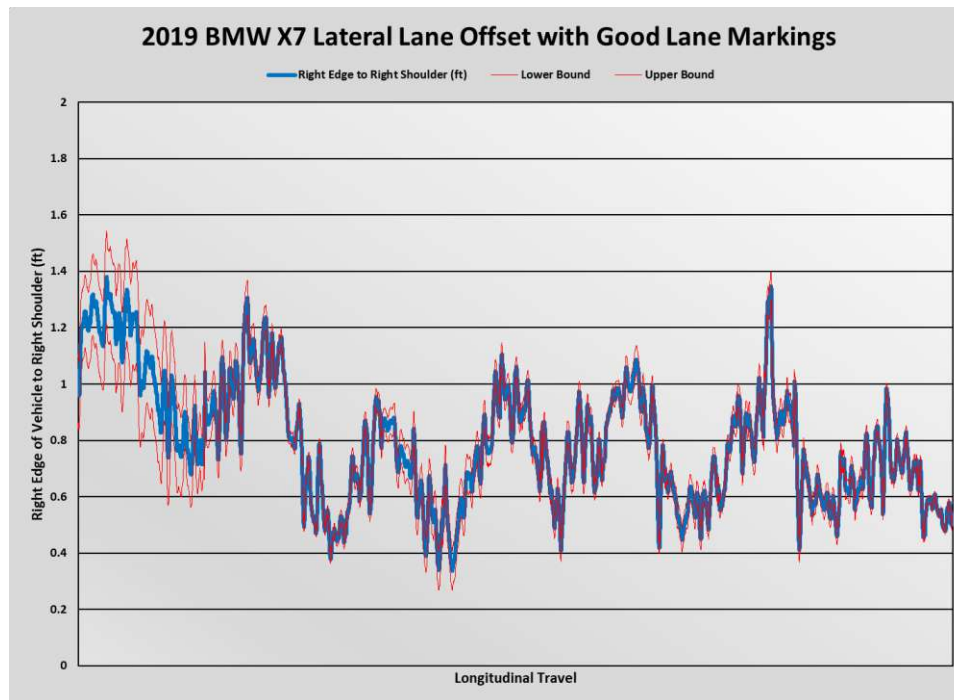
Figure 11: Average lateral lane offset with good lane markings Image Source: AAA

Figure 11 illustrates the lateral placement of the vehicle throughout the entirety of the testing lane. When traversing the roadway, the average lateral offset from the right shoulder was maintained between roughly 0.35 ft to 1.35 ft throughout the entirety of the testing lane. This implies acquisition of lane markings by the system; however, some variation with respect to lateral placement within the test lane was noted. The standard error calculated from all test runs is largely insignificant; this signifies consistent lane positioning from run to run for the evaluated roadway.

The vehicle remained slightly offset towards the right side of the testing lane throughout the entirety of the test. This observation does not imply negative performance as the vehicle remained within the lane during the entirety of the test.

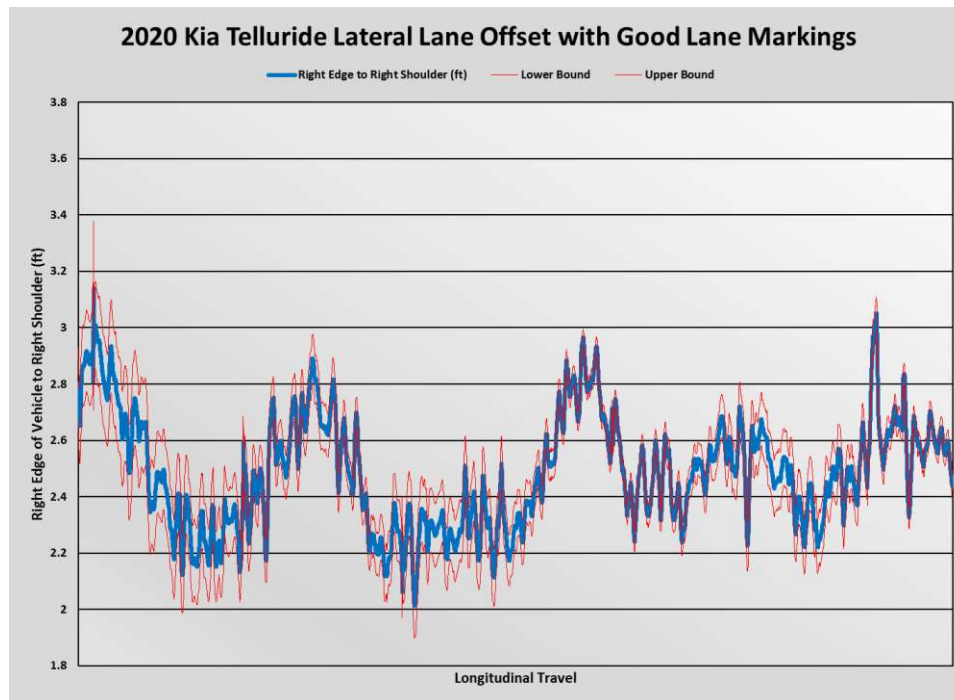
Figure 12: Average lateral lane offset with good lane markings Image Source: AAA

Figure 12 illustrates the lateral placement of the vehicle throughout the entirety of the testing lane. When traversing the roadway, the average lateral offset from the right shoulder was maintained between roughly 2.00 ft to 3.10 ft throughout the entirety of the testing lane. This implies acquisition of lane markings by the system; however, some variation with respect to lateral placement within the test lane was noted. The standard error calculated from all test runs is largely insignificant; this signifies consistent lane positioning from run to run for the evaluated roadway.

Within some areas along the roadway, the vehicle was somewhat offset towards the left side of the testing lane. This observation does not imply negative performance as the vehicle remained within the lane during the entirety of the test. However, this finding should be noted especially in the context of two-lane highways that are undivided from oncoming traffic.

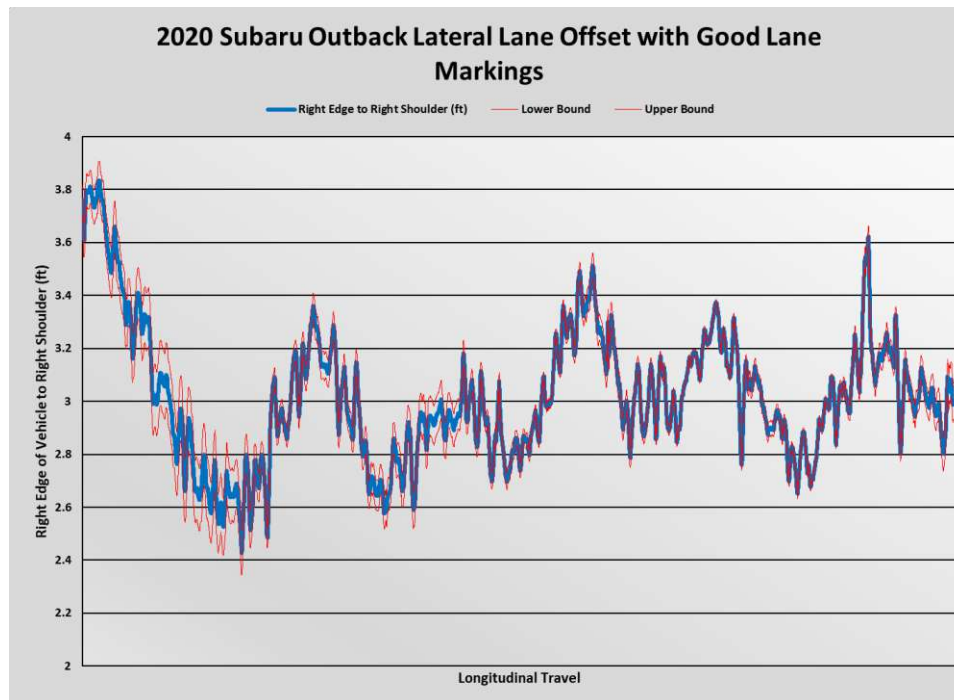
Figure 13: Average lateral lane offset with good lane markings Image Source: AAA

Figure 13 illustrates the lateral placement of the vehicle throughout the entirety of the testing lane. When traversing the roadway, the average lateral offset from the right shoulder was maintained between roughly 2.50 ft to 3.80 ft throughout the entirety of the testing lane. This implies acquisition of lane markings by the system; however, some variation with respect to lateral placement within the test lane was noted. The standard error calculated from all test runs is largely insignificant; this signifies consistent lane positioning from run to run for the evaluated roadway.

Within some areas along the roadway, the vehicle was offset towards the left side of the testing lane. This observation does not imply negative performance as the vehicle remained within the lane during the entirety of the test. However, this finding should be noted especially in the context of two-lane highways that are undivided from oncoming traffic.

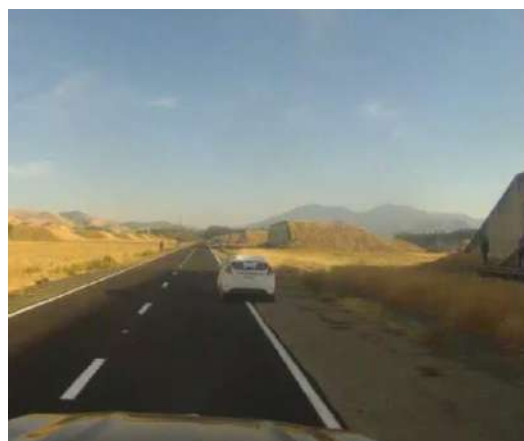
To simulate this situation, the DRI Soft Car 360® (herein referred to as the “target vehicle”) was parked approximately halfway off the right side of the testing lane previously described in [Section 4.2](#). In other words, the centerline of the vehicle was approximately located over the solid white line on the lateral side of the testing lane. The lateral placement of the target vehicle could be considered a best-case scenario in terms of detection opportunity with the exception of the target vehicle being placed directly in the center of the testing lane. In many cases when a disabled vehicle is partially within a roadway, it is common for only a small portion of the vehicle to obstruct the travel lane. A typical example would be a vehicle parked diagonally relative to the roadway with only the rear corner of the vehicle in the travel lane.

Figure 14: Lateral placement of DRI Soft Car 360® Image Source: AAA

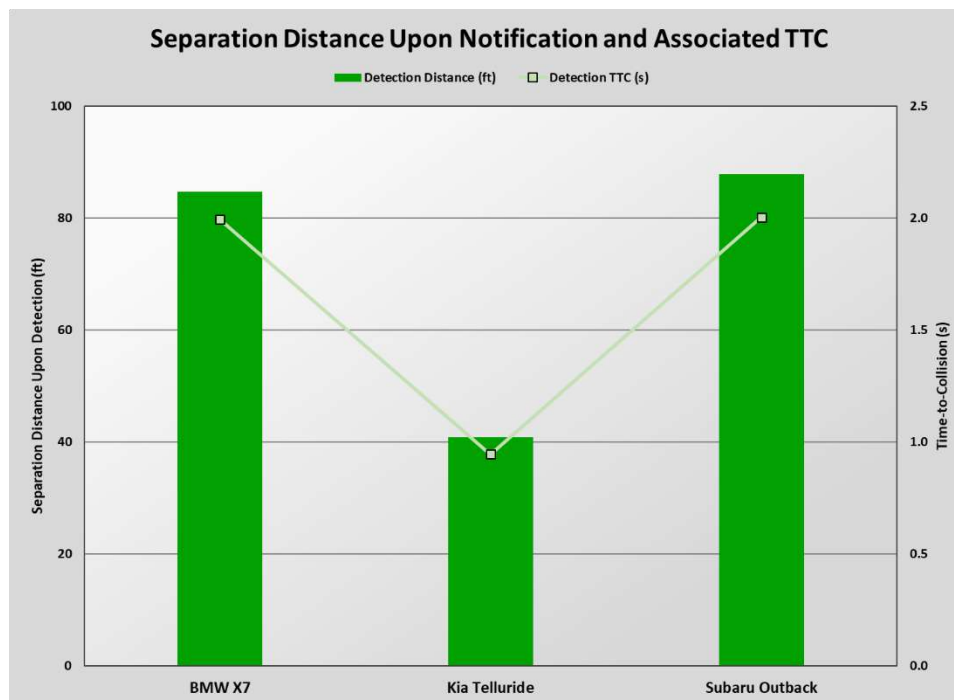
Figure 18: Average test vehicle detection distance and TTC Image Source: AAA

At 20 mph, each test vehicle provided notification of an imminent collision for a combined eight out of nine runs. Two out of three test vehicles completely avoided a collision with the target vehicle for at least one of three runs. However, for all nine test runs conducted in aggregate, a collision occurred 66 percent of the time.

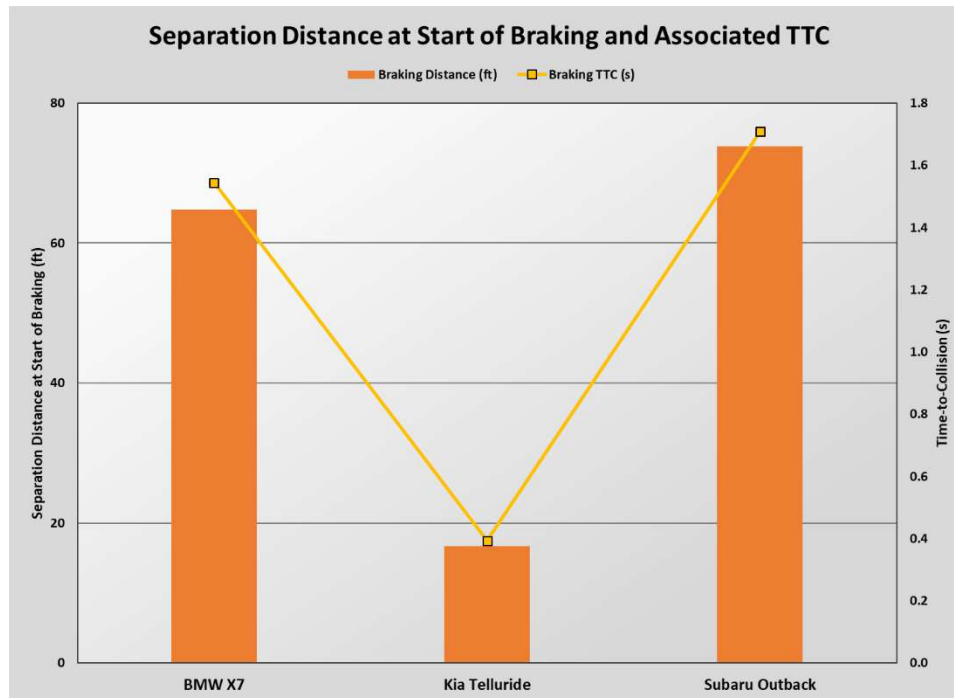
Figure 19: Average test vehicle braking distance and TTC Image Source: AAA

In a majority of cases, notification did not necessarily translate to collision avoidance. Specifically, while collision notification was provided for eight out of nine test runs in aggregate, a collision was avoided for only three out of nine runs. For collisions that occurred, the average impact and mitigation speed was 24.6 mph and 5.4 mph, respectively. It is also important to note for each test vehicle, performance varied significantly between the three test runs. Specifically, each test vehicle demonstrated some degree of inconsistency in terms of both detection and braking distance from run to run. Most importantly, each test vehicle impacted the target vehicle at least once. This illustrates that tested ADA systems cannot be trusted to consistently react to stopped vehicles either within or alongside the roadway. As such, drivers must maintain awareness of their surroundings and control of the vehicle at all times.

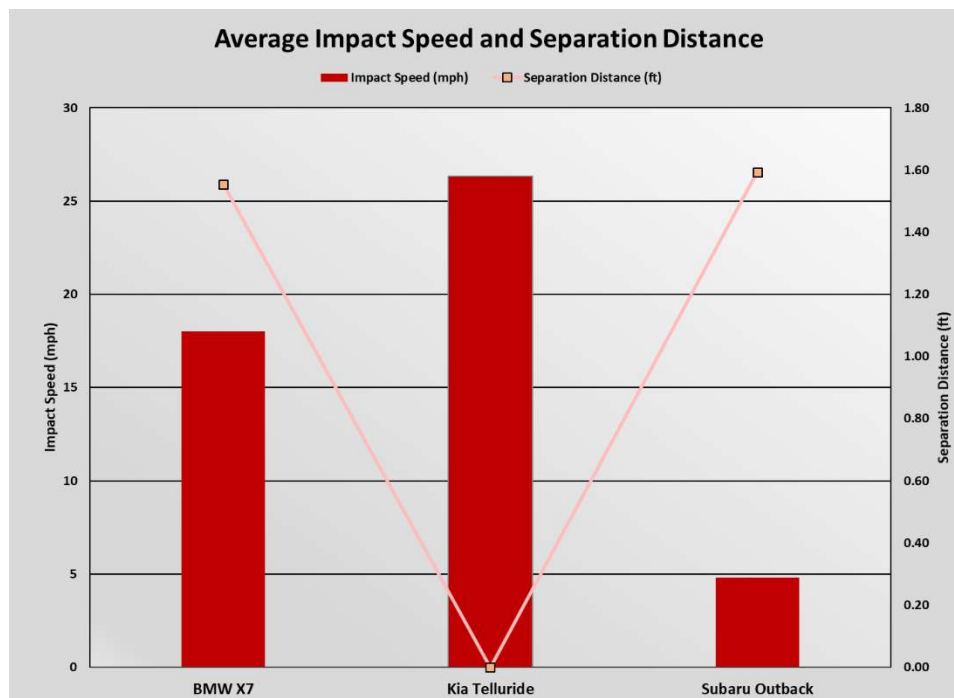
Figure 20: Average test vehicle impact speed and separation distance Image Source: AAA

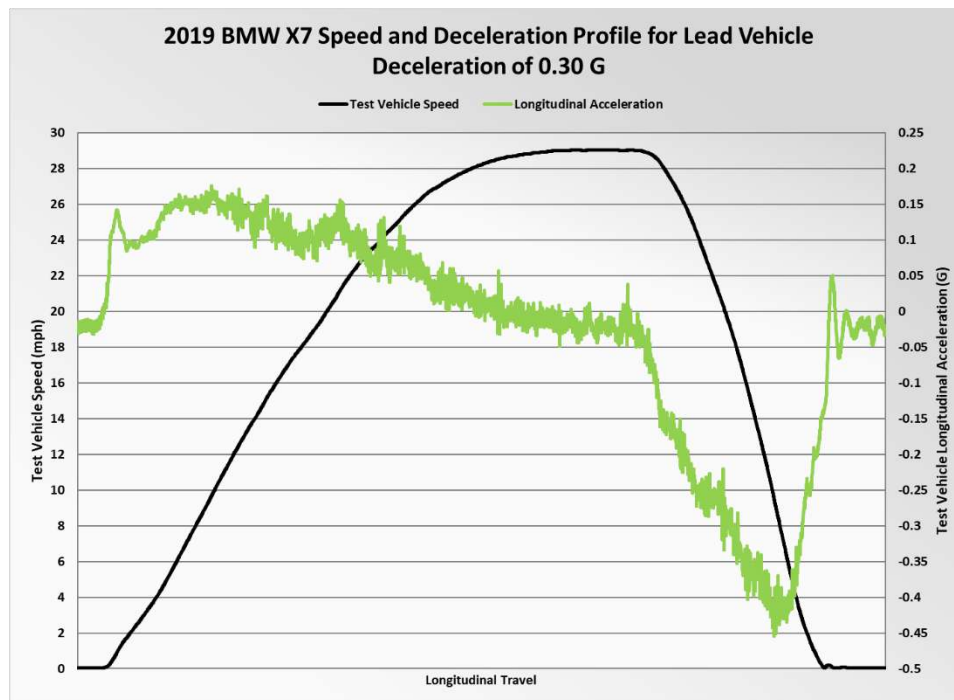
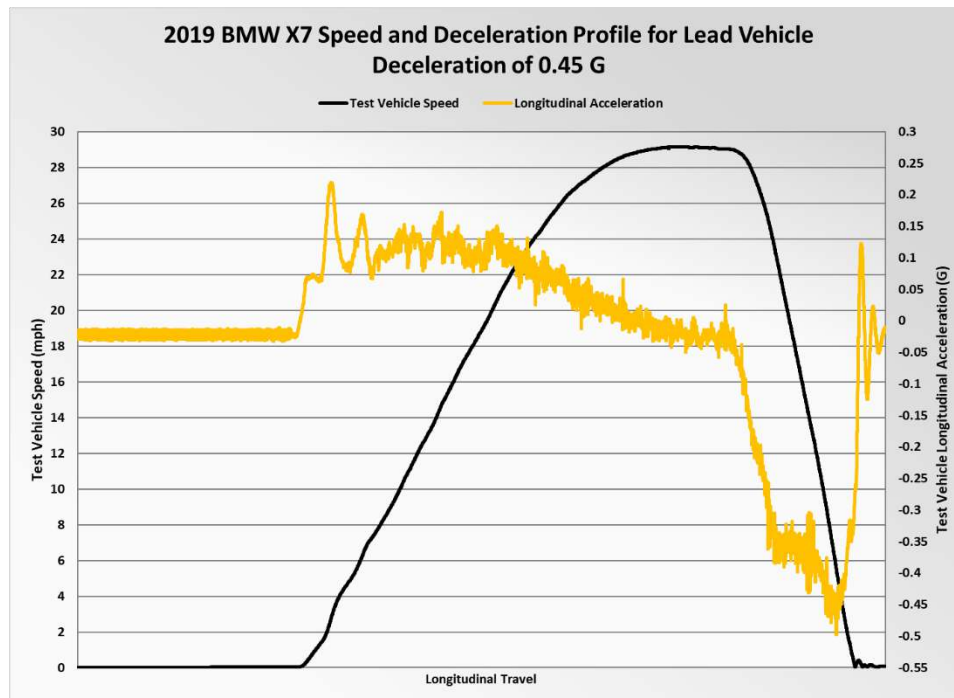
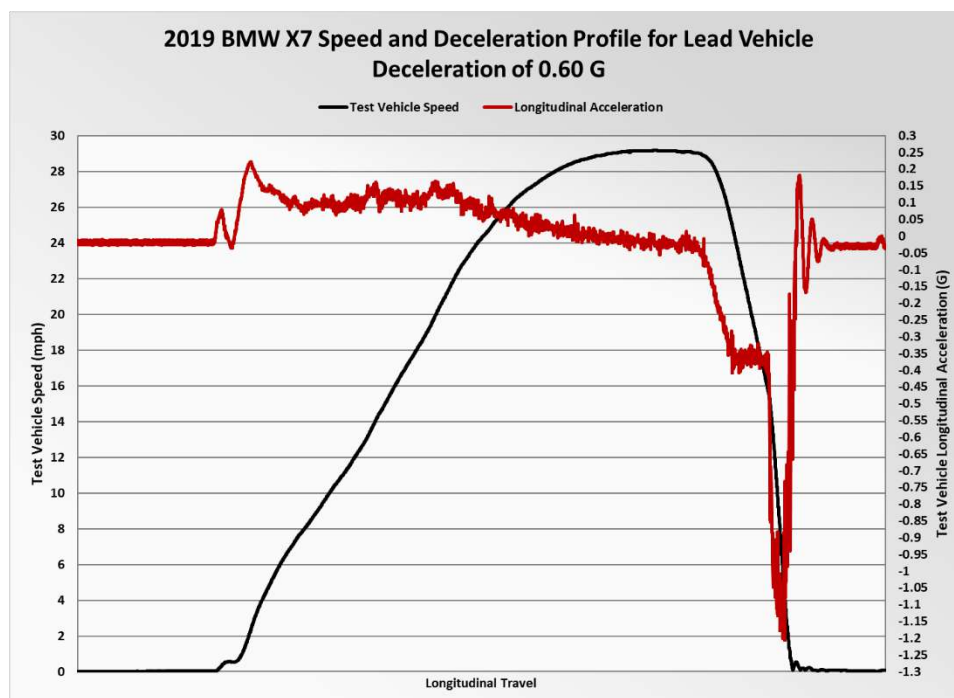
Figure 22: 2019 BMW X7 characteristic deceleration profile (0.30 G lead vehicle deceleration) Image Source: AAA

Figure 23: 2019 BMW X7 characteristic deceleration profile (0.45 G lead vehicle deceleration) Image Source: AAA

Figure 24: 2019 BMW X7 characteristic deceleration profile (0.60 G lead vehicle deceleration) Image Source: AAA

Figures 22-24 illustrate the deceleration profiles associated with each lead vehicle deceleration rate. At 0.30 G, the system decelerated smoothly as shown by the mostly linear rate of deceleration with a

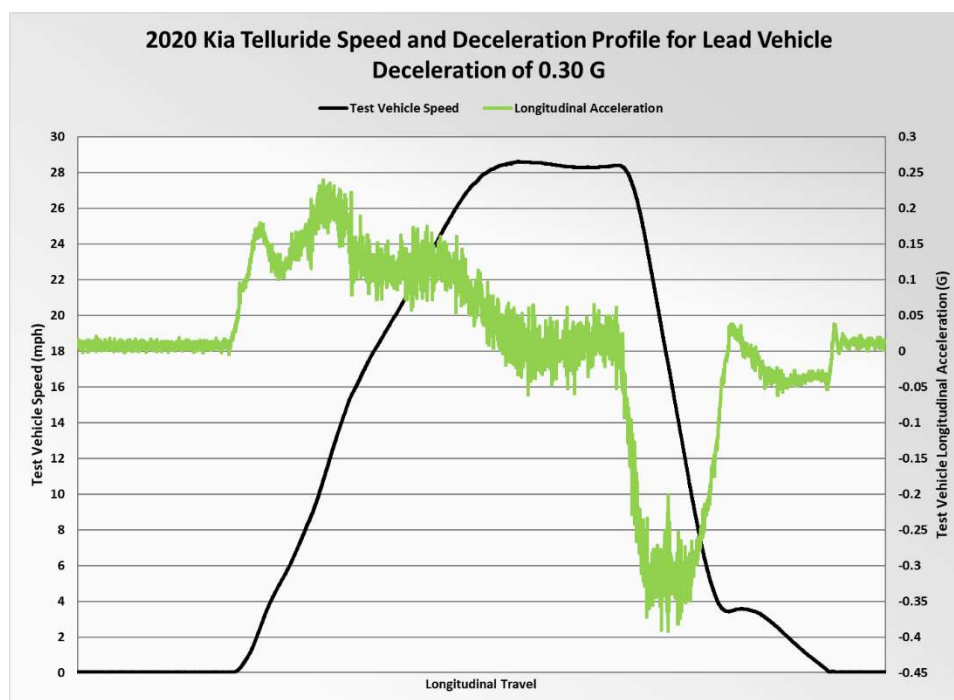
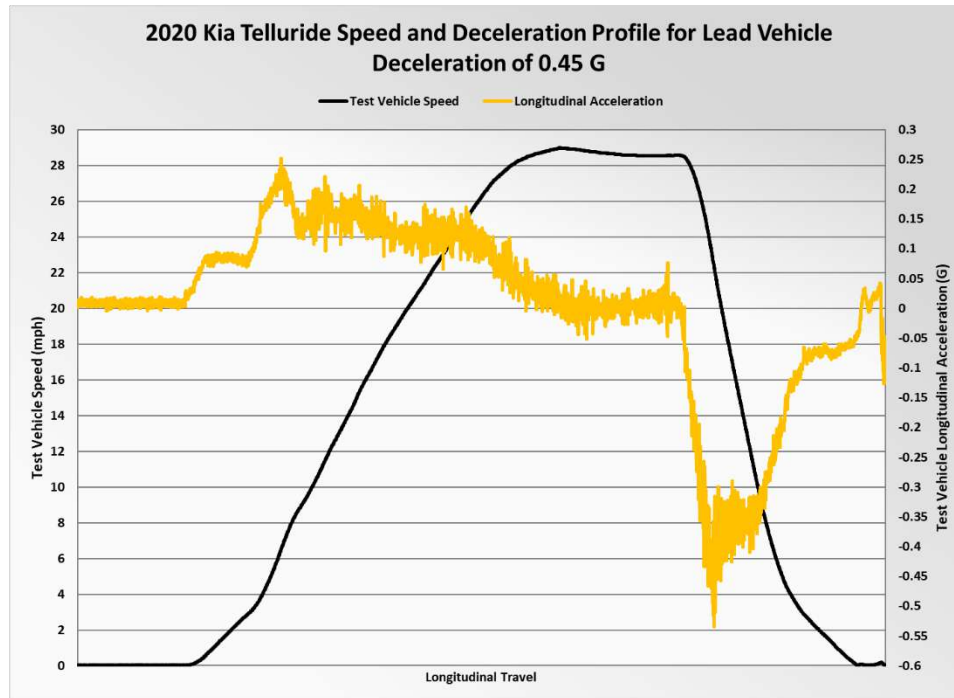
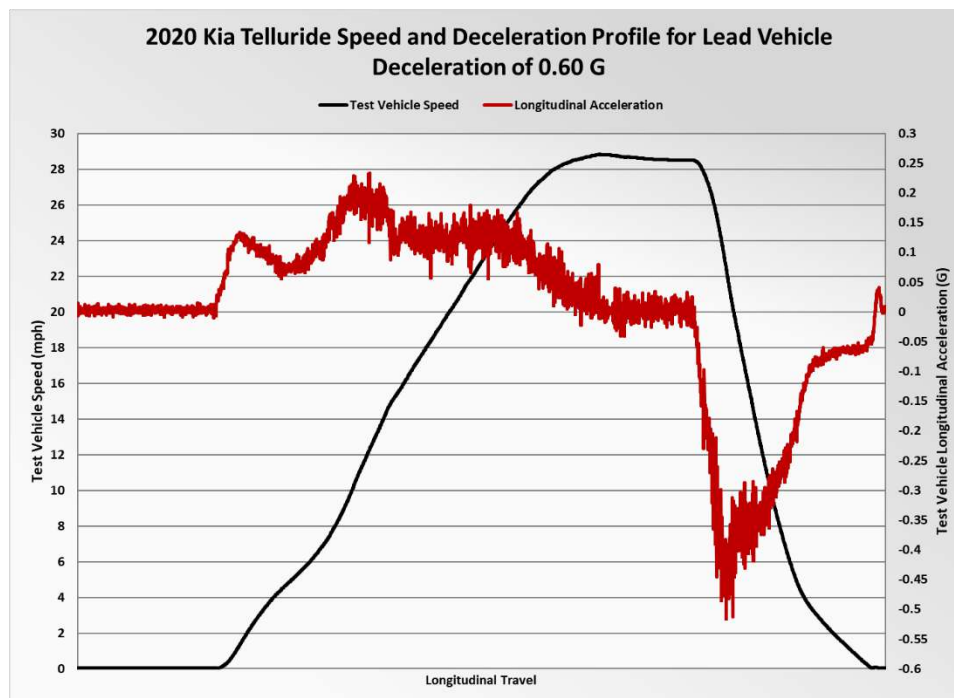
Figure 26: 2020 Kia Telluride characteristic deceleration profile (0.30 G lead vehicle deceleration) Image Source: AAA

Figure 27: 2020 Kia Telluride characteristic deceleration profile (0.45 G lead vehicle deceleration) Image Source: AAA

Figure 28: 2020 Kia Telluride characteristic deceleration profile (0.60 G lead vehicle deceleration) Image Source: AAA

Figures 26-28 illustrate characteristic deceleration profiles associated with each lead vehicle deceleration rate. All deceleration profiles exhibit similar characteristics including a linearly increasing deceleration rate to a plateau between 0.35 G to 0.40 G. After the rate plateaus, the deceleration rate gradually decreases as the vehicle comes to a stop. At 0.30 G, the vehicle crept forward momentarily before coming to a complete stop. Regardless of lead vehicle deceleration rate, stops were noticeably smooth relative to other test vehicles.

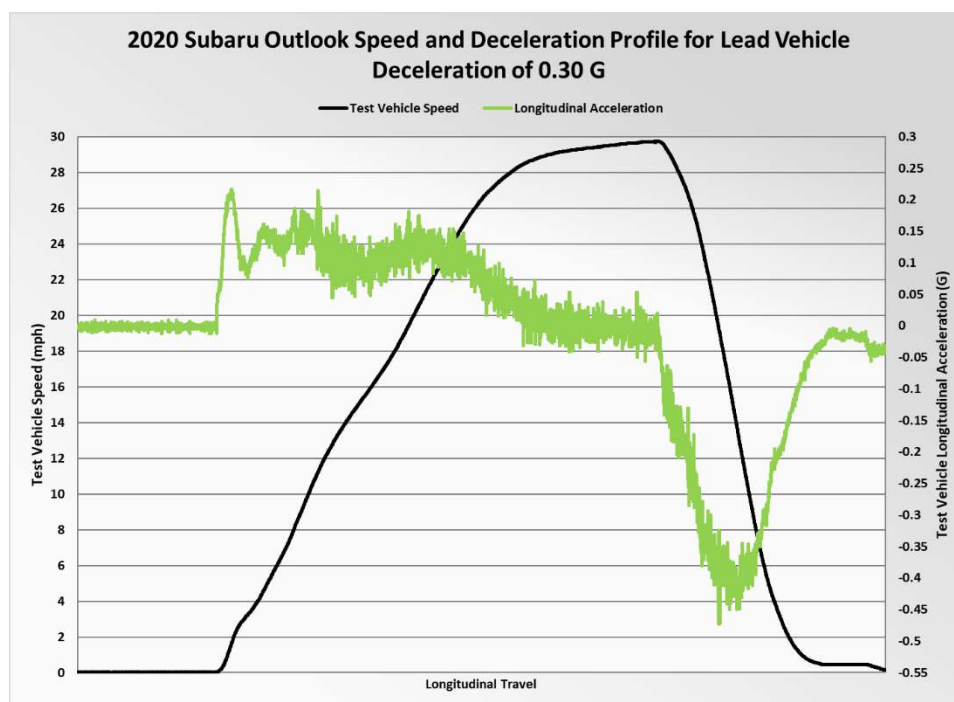
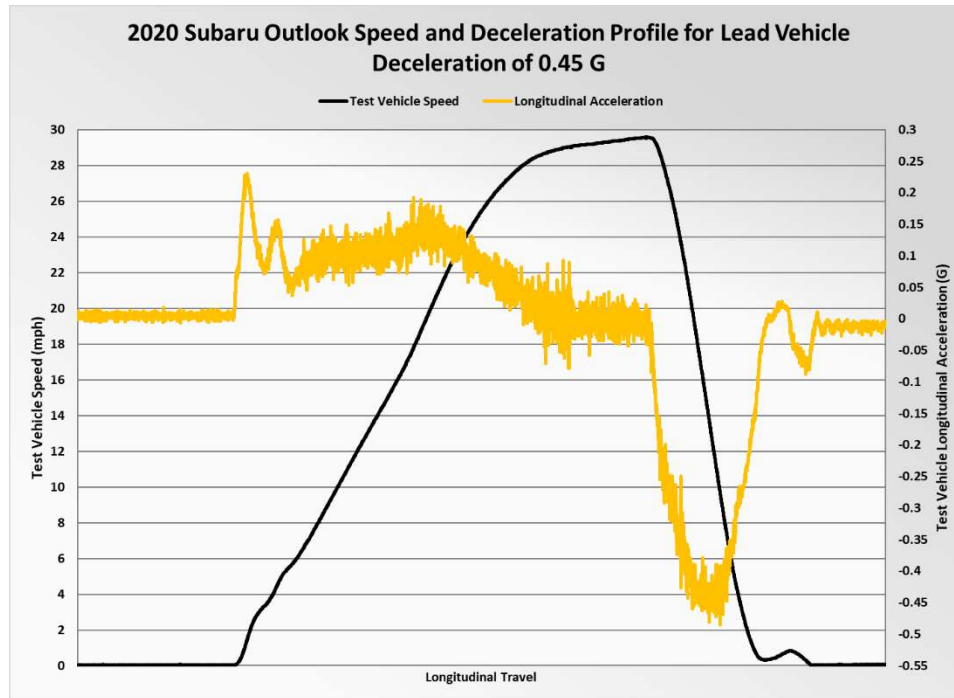
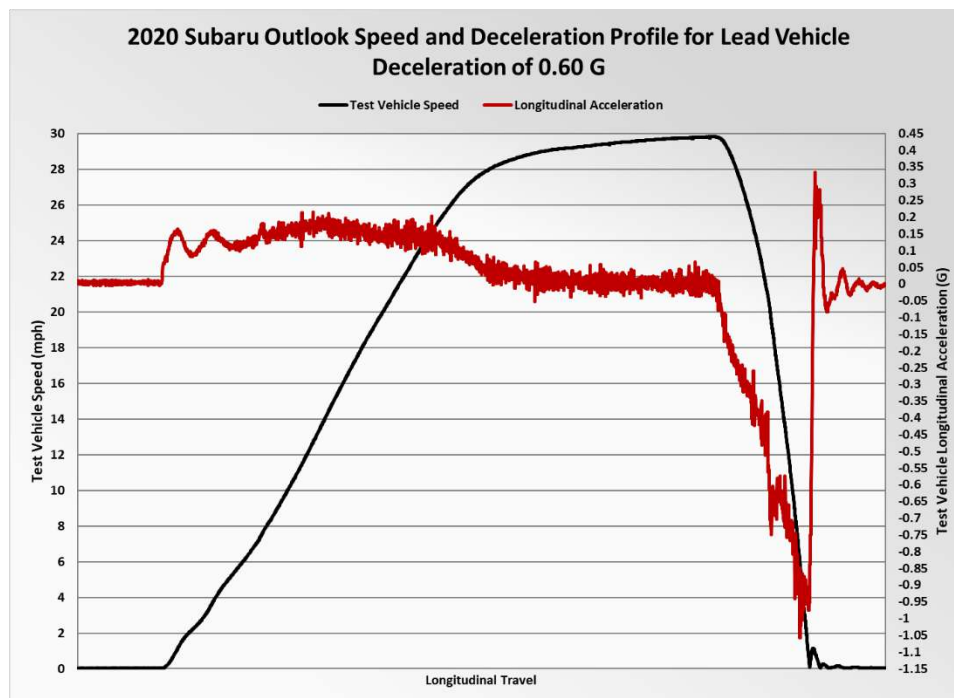
Figure 30: 2020 Subaru Outlook characteristic deceleration profile (0.30 G lead vehicle deceleration) Image Source: AAA

Figure 31: 2020 Subaru Outlook characteristic deceleration profile (0.45 G lead vehicle deceleration) Image Source: AAA

Figure 32: 2020 Subaru Outlook characteristic deceleration profile (0.60 G lead vehicle deceleration) Image Source: AAA

Figures 30-32 illustrate characteristic deceleration profiles associated with each lead vehicle deceleration rate. At 0.30 G and 0.45 G, the system decelerated with a linearly increasing rate and plateaued approximately between 0.40 G to 0.45 G before linearly decreasing until the vehicle was almost stopped. At this point, the vehicle crept forward slightly before coming to a complete stop. At 0.60 G, the system exhibited a multi stepwise deceleration profile with brief plateaus at 0.40 G and 0.65 G before increasing to a maximum at approximately 1.00 G. This maximum rate was maintained until the vehicle came to a stop, resulting in a noticeably abrupt stop.

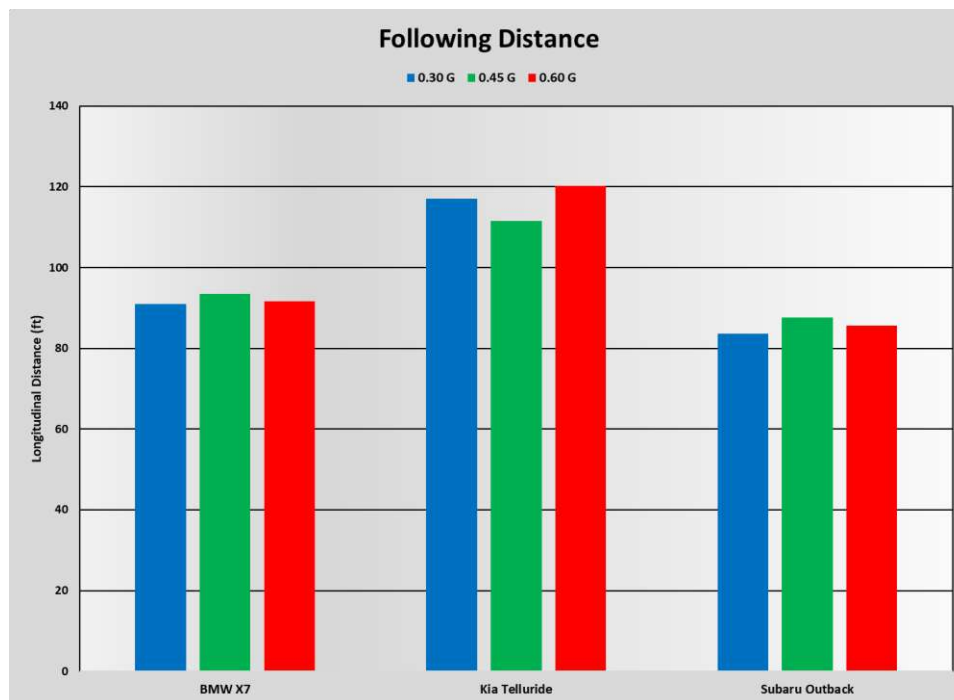
Figure 33: Average test vehicle following distance Image Source: AAA

Figure 33 illustrates for each test vehicle, differences in following distance with respect to lead vehicle deceleration were not significant. This is an expected result; the only parameter that is anticipated to influence following distance is vehicle speed. For all runs, the test vehicle nominal speed was kept constant at 30 mph.

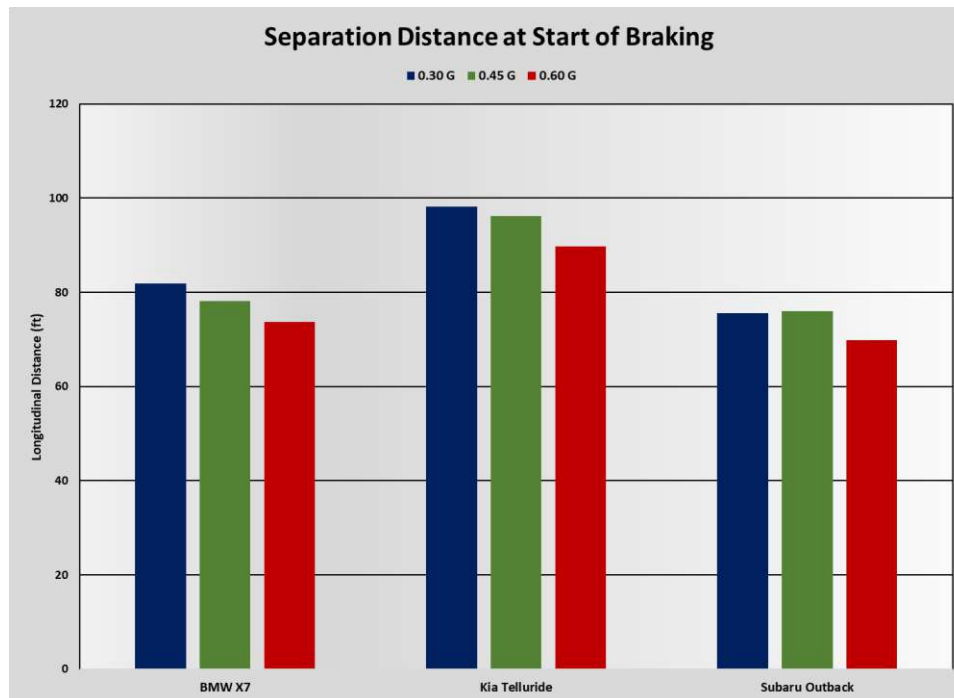
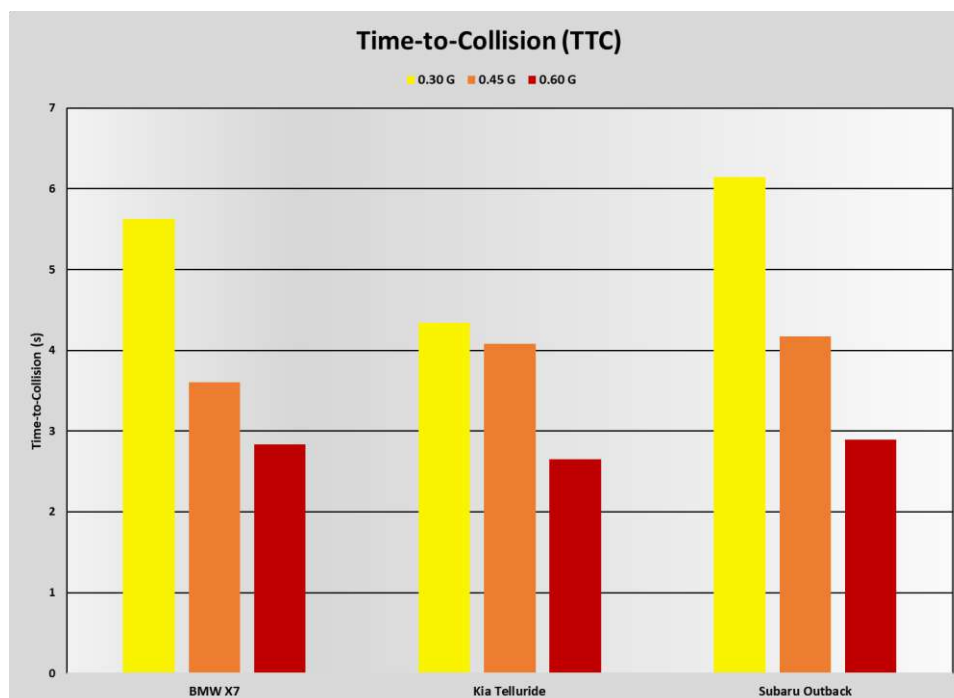
Figure 34: Average separation distance at start of braking Image Source: AAA

Figure 35: Average test vehicle TTC at start of braking Image Source: AAA

For two out of three test vehicles, the average separation distance at the start of braking slightly decreased as the lead vehicle deceleration rate increased. As a result of decreased separation distance

and increased lead vehicle deceleration, the time-to-collision consequently decreased as the lead vehicle deceleration rate increased.

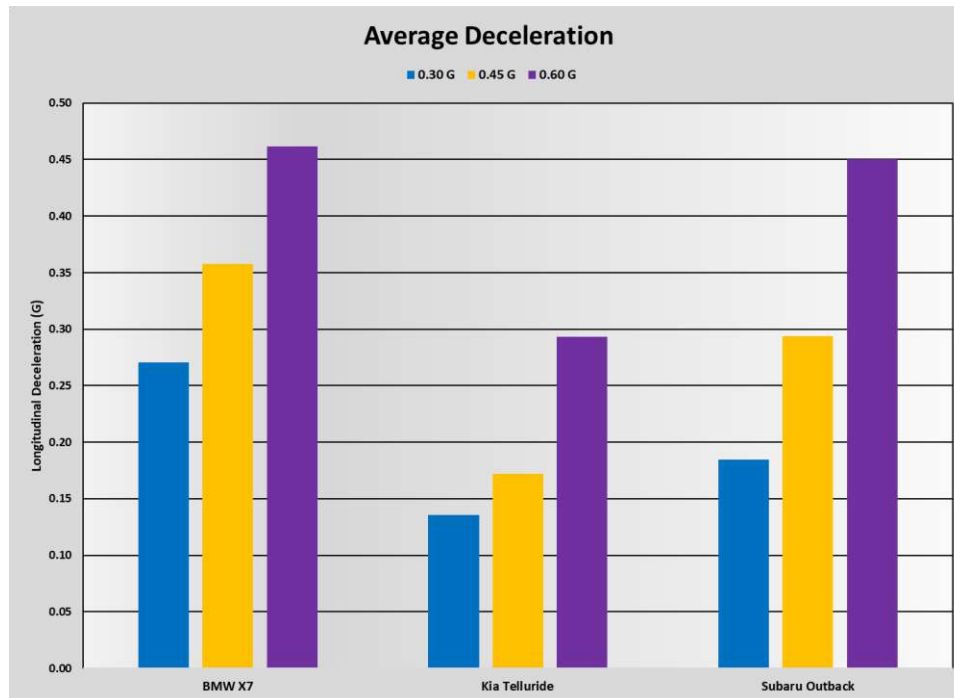
Figure 36: Average test vehicle deceleration Image Source: AAA

For each test vehicle, the average deceleration rate increased as the lead vehicle deceleration rate increased as shown in Figure 36. Additionally, the maximum instantaneous deceleration increased along with lead vehicle deceleration as shown in Figure 37. Two out of three test vehicles exhibited instantaneous maximum decelerations exceeding 1.0 G. This illustrates evaluated systems are capable of applying significant braking input in response to lead vehicle deceleration. However, abrupt stops with high deceleration rates may introduce the possibility of rear-end collisions because following vehicles will have limited time to react.

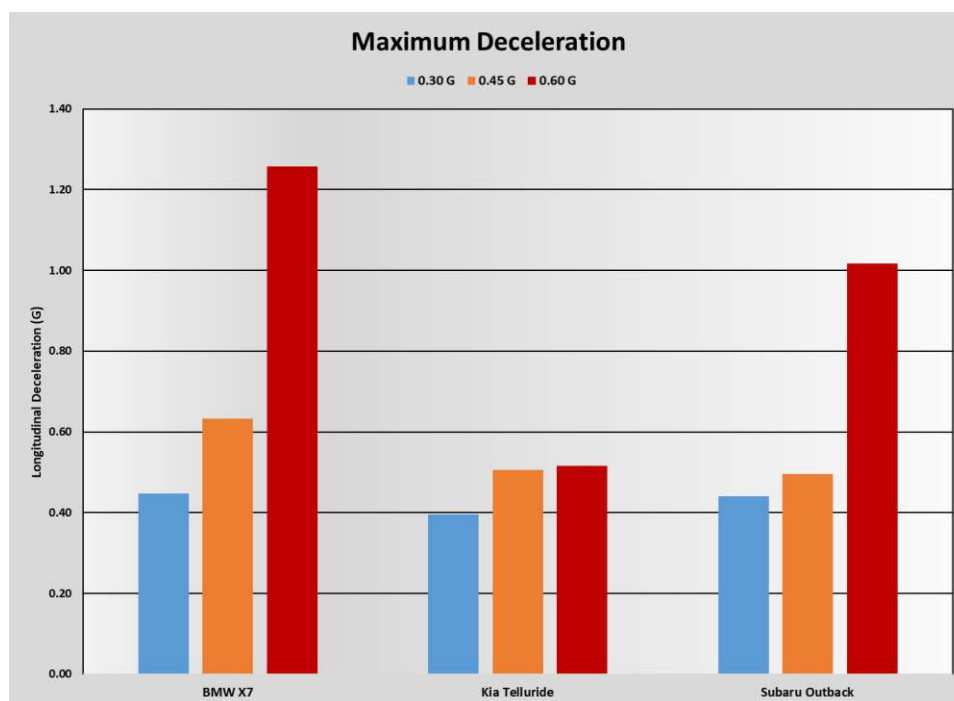
Figure 37: Averaged maximum instantaneous test vehicle deceleration Image Source: AAA

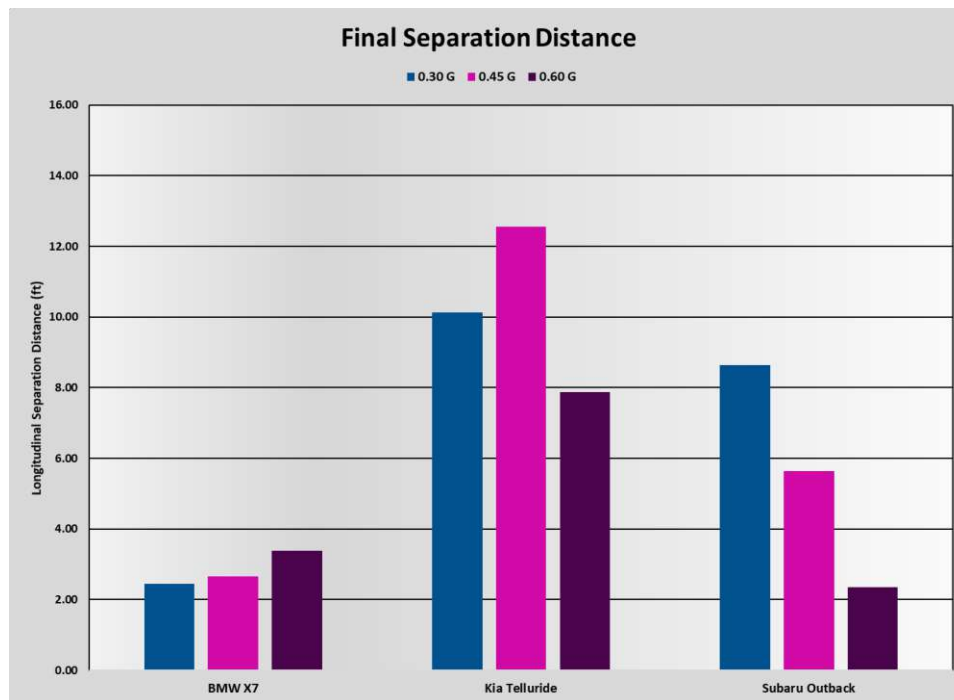
Figure 38: Average test vehicle/lead vehicle separation distance Image Source: AAA

The final separation distance did not vary consistently among test vehicles with respect to lead vehicle deceleration rate as shown in Figure 38. Specifically, the final separation distance slightly increased with increasing lead vehicle deceleration for the BMW X7 whereas the opposite is true for the Subaru Outback. However, the most significant finding is all test vehicles avoided contact with the lead vehicle for all test runs conducted regardless of tested lead vehicle deceleration rate.

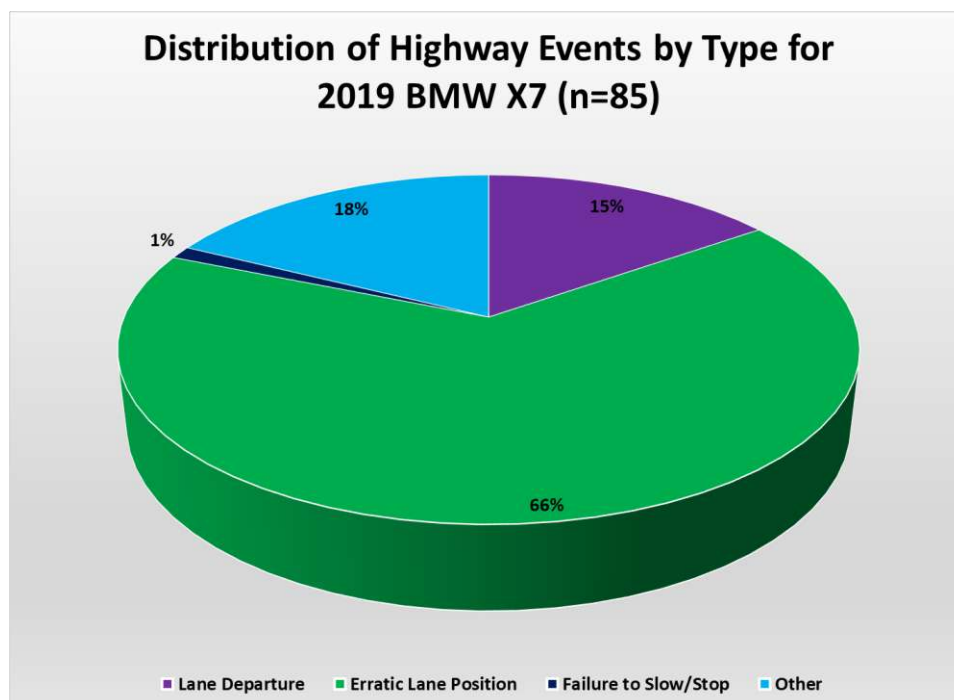
Figure 40: Percent distribution of events by type for the 2019 BMW X7 Image Source: AAA

Figures 39 and 40 illustrate the total number and distribution of each event type observed during naturalistic evaluation. In total, approximately 800 miles were traversed; this translates into roughly one event every 9 miles for the roadways traveled.

Sixty-six percent of events were classified as erratic lane positioning and an additional 15 percent of events were classified as lane departures. In total, 81 percent of noted events pertained to the lane keeping functionality of the BMW's Active Driving Assistant Professional system. Despite this finding, some test drivers noted good general performance in slight and moderate curves. Most test drivers also felt the system performed well during periods of light highway traffic and stop-and-go traffic.

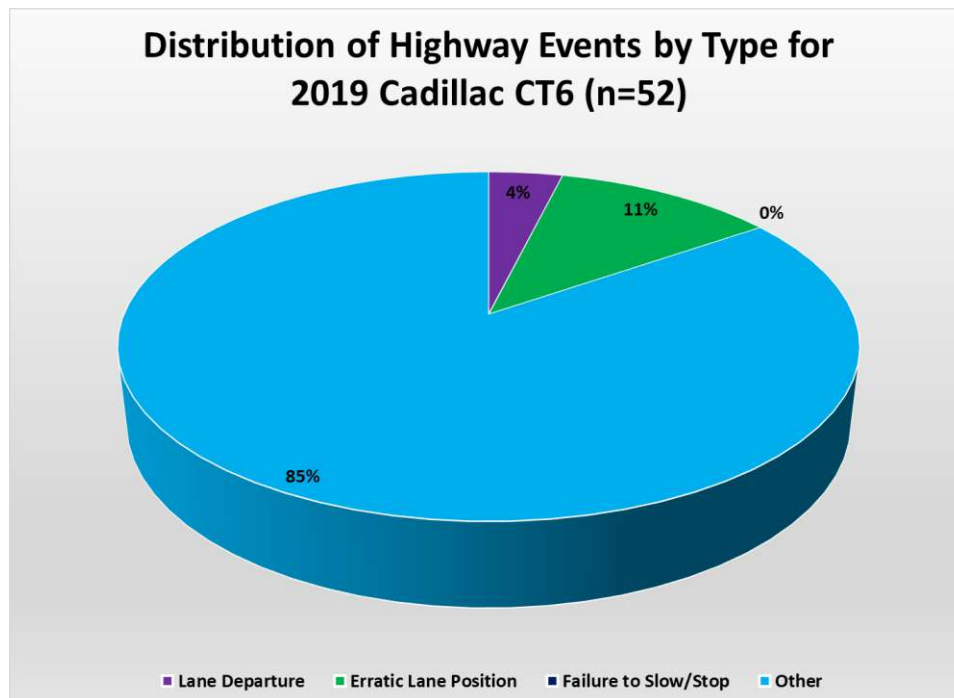
Figure 43: Percent distribution of events by type for the 2019 Cadillac CT6 Image Source: AAA

Figures 42 and 43 illustrate the total number and distribution of each event type observed during naturalistic evaluation. In total, approximately 800 miles were traversed; this translates into roughly one event every 15 miles for the roadways traveled.

Eighty-five percent of events were classified as “other”; 37 out of 44 of these events were either unexpected or erroneous system disengagements. Some disengagements occurred at critical times such as in the middle of a curve with rapidly slowing traffic ahead. While it was easily apparent disengagement occurred, test drivers were sometimes taken by surprise and were required to retake full control in the middle of critical situations with little to no advance notice. Additionally, a significant number of disengagements were noted during which driver inattention was incorrectly detected. This occurred with enough frequency to noticeably detract from the driving experience.

interstates with the system engaged. To maintain consistency in terms of event counting relative to other test vehicles, events noted during this evaluation were not included in Figures 42 and 43.

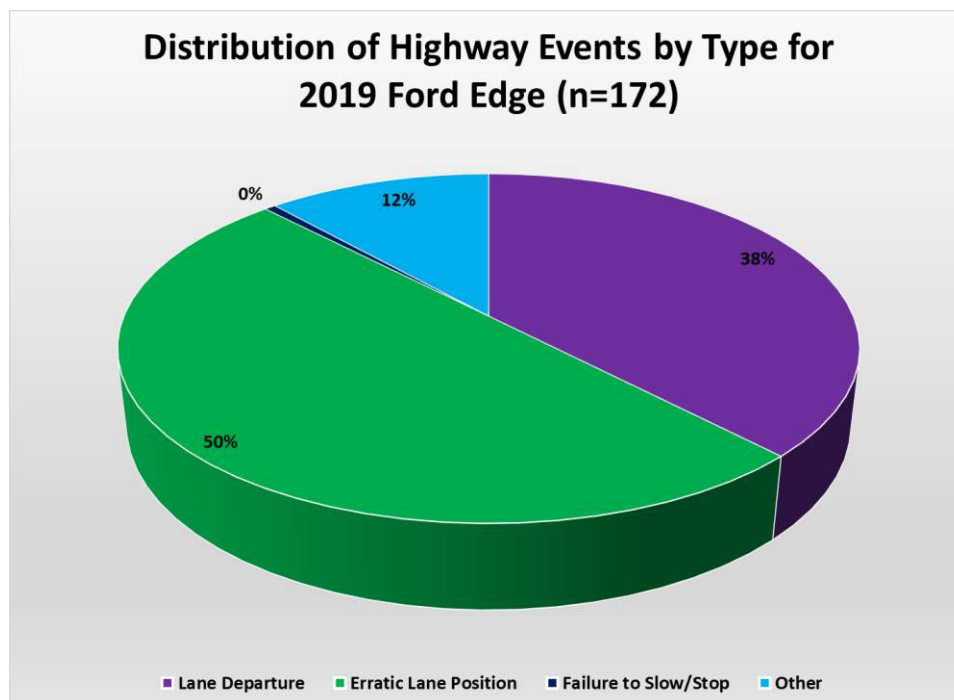
Figure 46: Percent distribution of events by type for the 2019 Ford Edge Image Source: AAA

Figures 45 and 46 illustrate the total number and distribution of each event type observed during naturalistic evaluation. In total, approximately 800 miles were traversed; this translates into roughly one event every 5 miles for the roadways traveled.
