**AUGUST 2020**

# **EVALUATION OF ACTIVE DRIVING ASSISTANCE SYSTEMS**

In 2018, AAA evaluated four vehicles equipped with active driving assistance (ADA) systems. In common language, these systems assist the driver with vehicle acceleration, braking and steering. SAE<sup>1</sup> International defines various levels of driving automation within standard J3016 [1] and ADA systems currently available within the United States are considered to be Level 2 systems per this standard. To build upon work AAA conducted in 2018, the performance of five additional vehicles equipped with ADA systems was characterized.

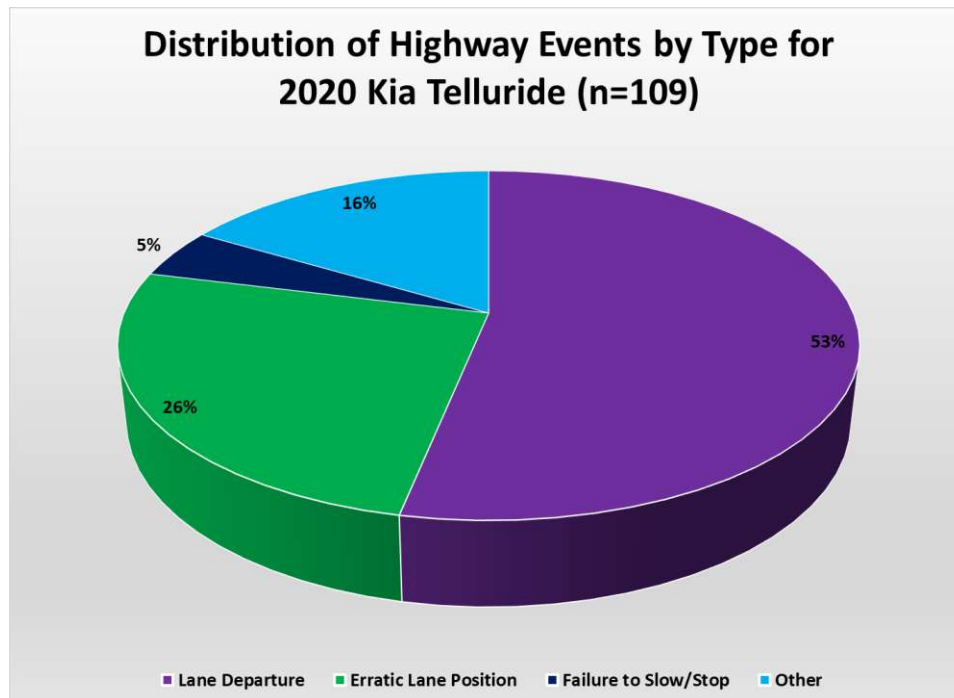
**Figure 49: Percent distribution of events by type for the 2020 Kia Telluride** Image Source: AAA

Figures 48 and 49 illustrate the total number and distribution of each event type observed during naturalistic evaluation. In total, approximately 800 miles were traversed; this translates into roughly one event every 7 miles for the roadways traveled.

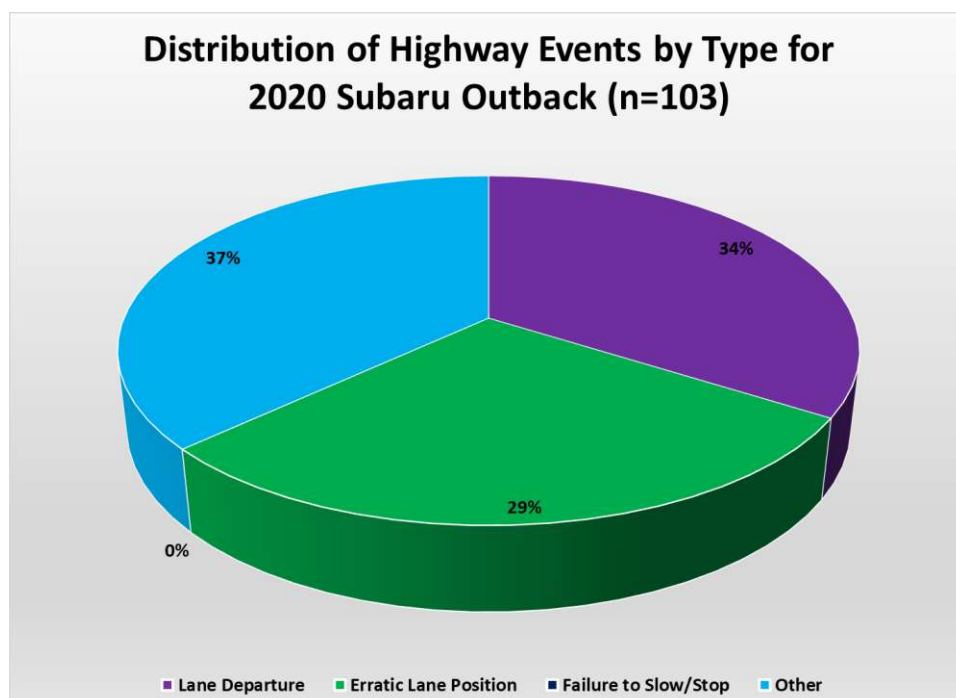
Figure 52: Percent distribution of events by type for the 2020 Subaru Outback Image Source: AAA

Figures 51 and 52 illustrate the total number and distribution of each event type observed during naturalistic evaluation. In total, approximately 800 miles were traversed; this translates into roughly one event every 8 miles for the roadways traveled.

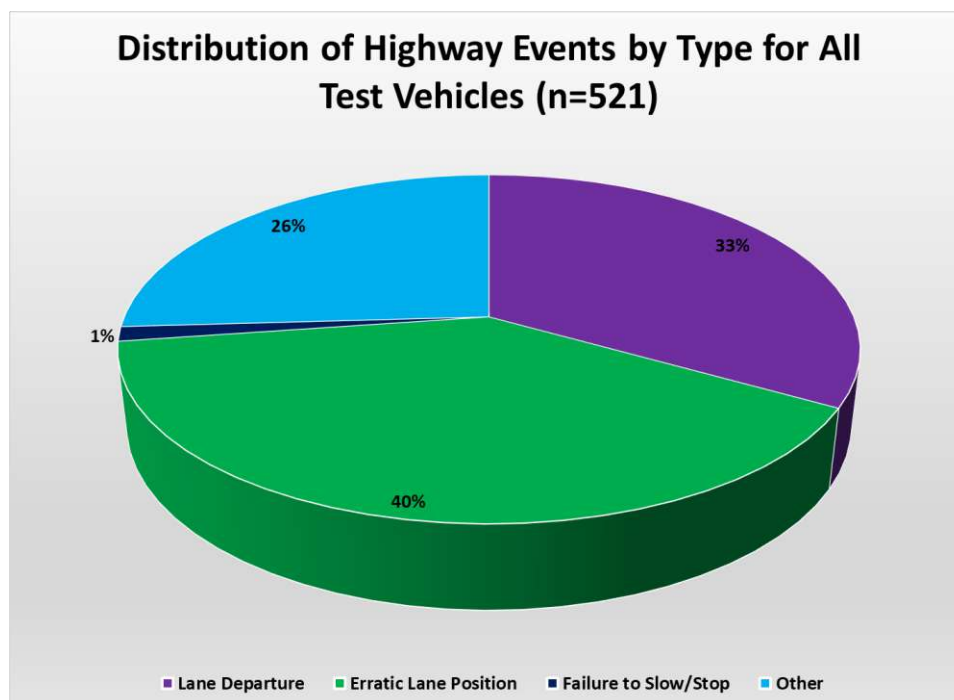
Figure 55: Percent distribution of events by type for all test vehicles Image Source: AAA

Based on findings from earlier work, naturalistic evaluations exclusively focused on the highway environment. In general, all test drivers noted the adaptive cruise functionality of evaluated systems performed well, sometimes exceeding expectations. However, each test driver noted some degree of flawed performance during each drive of every test vehicle in terms of lane-keeping functionality. The specific nature of lane-keeping events were varied; common events are listed below:
